# CASSINGTON TORNADO 2021

## Report by the Tornado and Storm Research Organisation (TORRO)

On 31st October 2021, a tornado went through the village of Cassington. This report covers the findings from a site investigation conducted by Sarah Horton (TORRO) over two days following the event

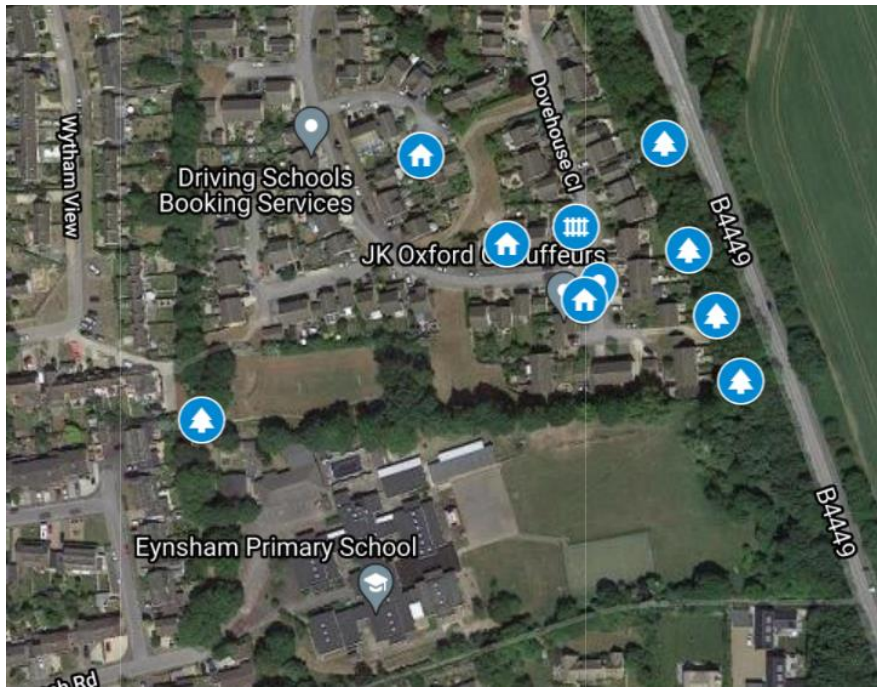
### Eynsham

The most south-western point of damage found was close to Eynsham Primary school and consisted of large branches from a tree. These had been tidied into a pile and so direction of fall could not be ascertained.

There was some tile damage to houses close to the B4449. One garden wall had partially collapsed. Several large trees had lost branches or snapped high up.

Estimated strength at this point T1 Width 120m.

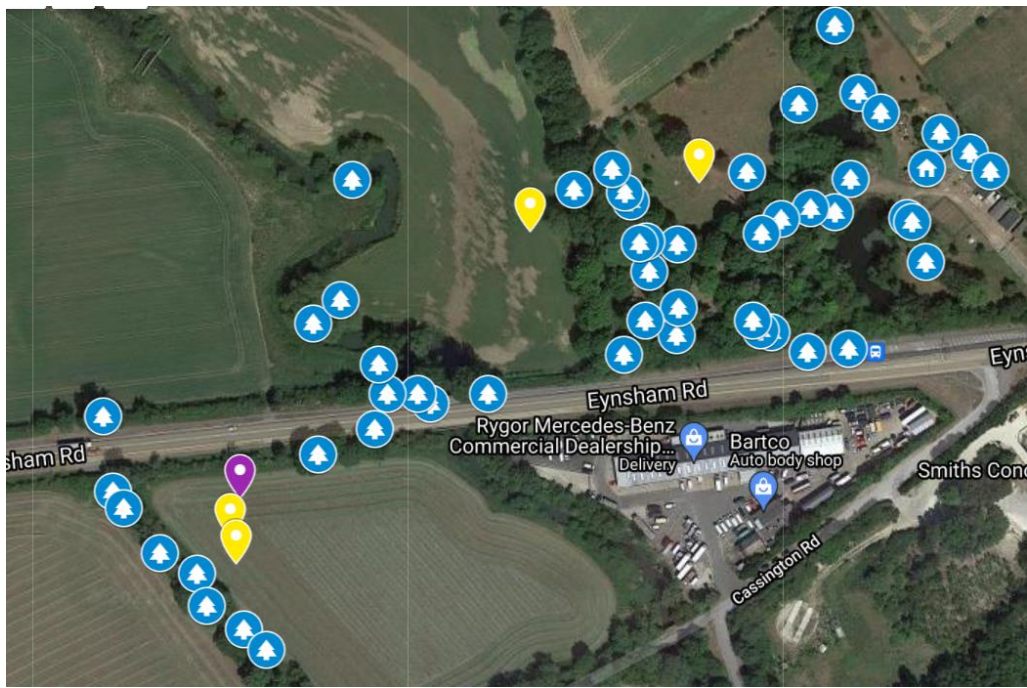
Land bordering the A40 near the Cassington Turn.

Note that much of the tree damage shown here is indicative. Such was the density of felled trees, it was impossible to walk through much of it. Damage to the bottom left of the image was less severe than damage through the woodland shown. The yellow markers are a few examples of debris that travelled. The Purple marker indicates a particularly notable example.

To the south of Eynsham road in the field, many trees were damaged. The line gives a good indicator of the width of the tornado at this point. c. 160m

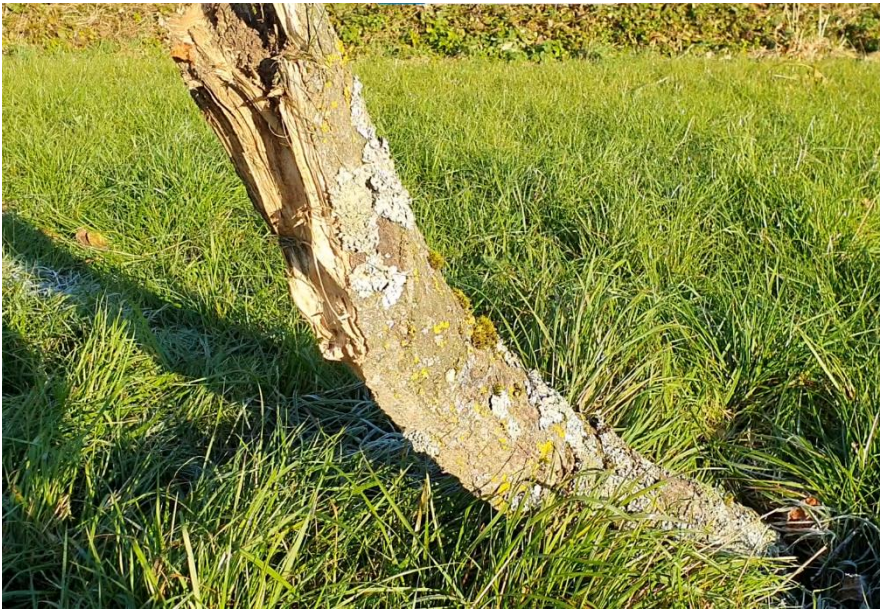
The purple marker shown on the map is where this branch impaled the ground. It was over 1m long and around 15cm in diameter. It was embedded around 20cm deep. It had travelled around 40m before becoming embedded. Other tree debris was scattered across the field.

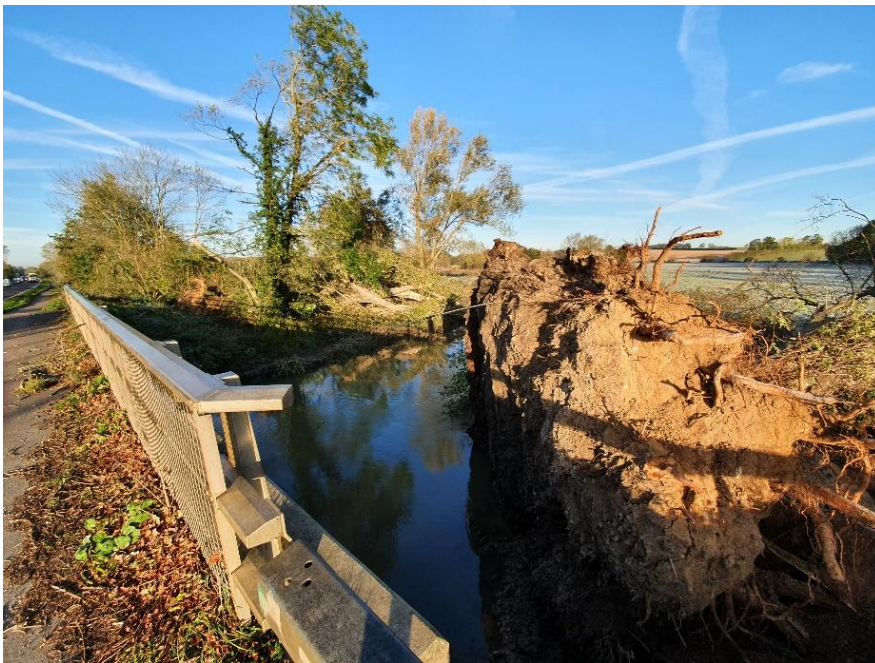
Two extremely large poplar trees had been completely uprooted alongside the River Evenlode. There was much evidence of twisting on broken branches. Debris had been scattered to the north.

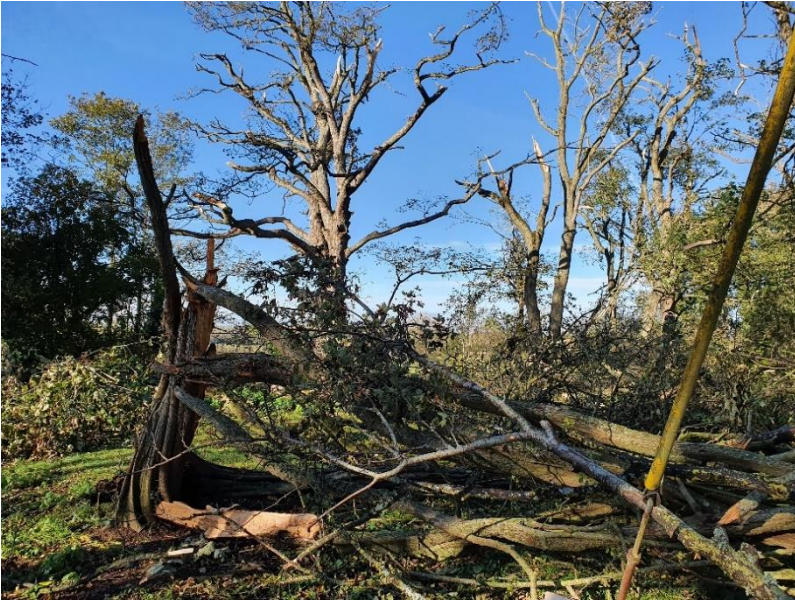
Access was given to this woodland by the owners of the property and a tour was given of the damage. The trees shown are merely an indicative sample as it was too dangerous to walk through some of it and access was blocked by the fallen trees.

Large tree branches had become projectiles. There was clear evidence of a twisting force having been applied to them.

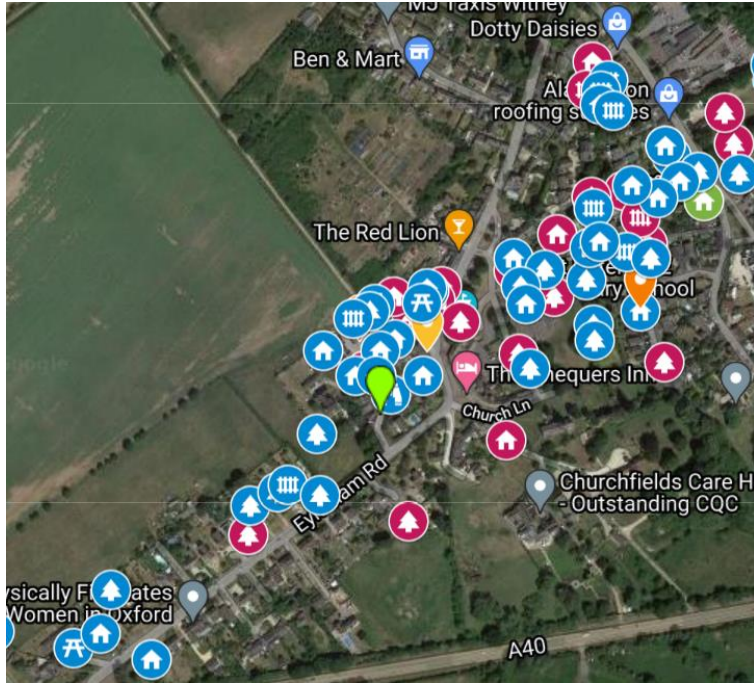
### Cassington Village centre.

As with the previous map, some damage will not have been marked. Village residents were extremely helpful in helping to identify damage, both online and in person during the site visit. On the south-eastern side of Eynsham road, very little damage was found despite speaking to residents.

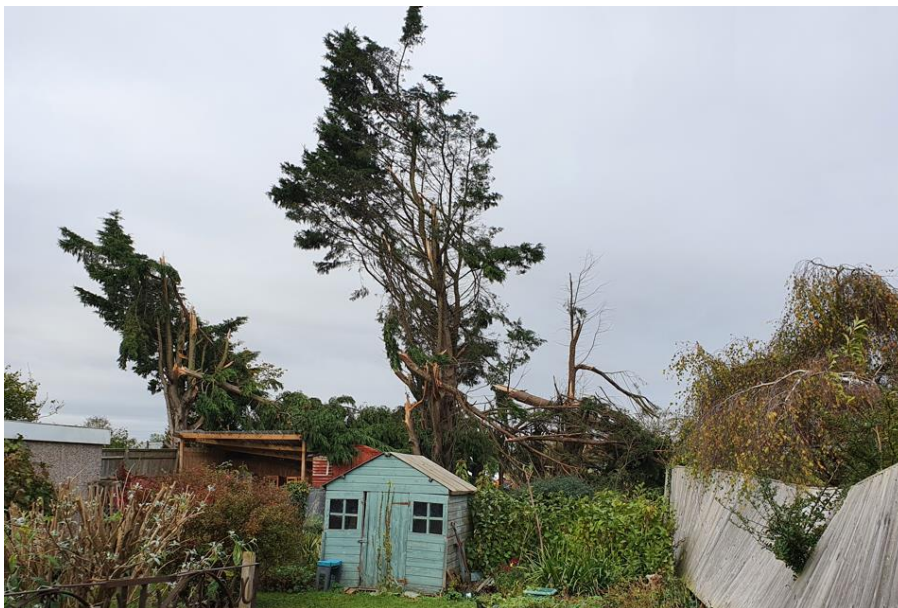
From the road some damage was evident to large trees and a fence.

In Hollow Furlong, one witness said that she saw branches and leaves swirling on the eastern side of the property. Afterwards leaves were plastered to the window. Tiles had come off from both sides of a garage.

In Williams Court, roof tiles travelled approximately 20-30m denting a car. Another car had its windscreen smashed from falling tiles.

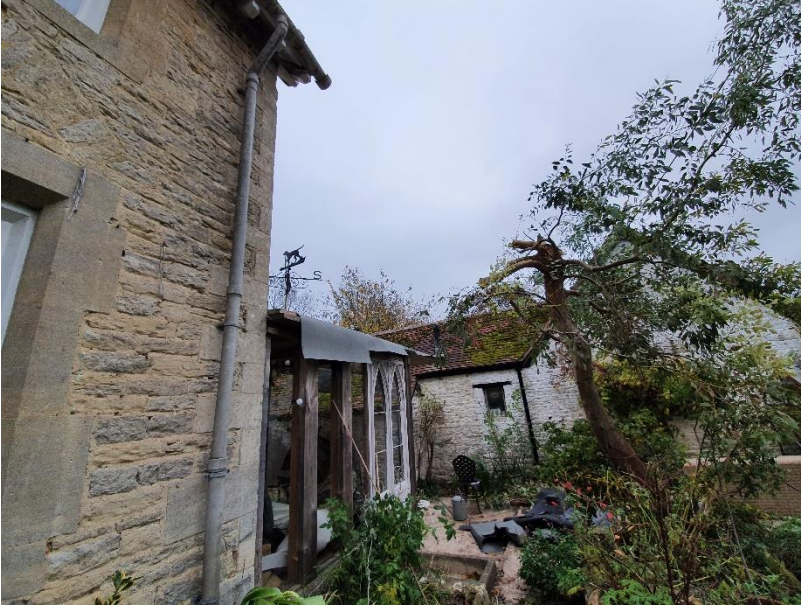
One resident described his window smashing, gutters being removed, roof felt lifting and damage to trees and plants. He found carpet underlay in his garden, origin unknown.

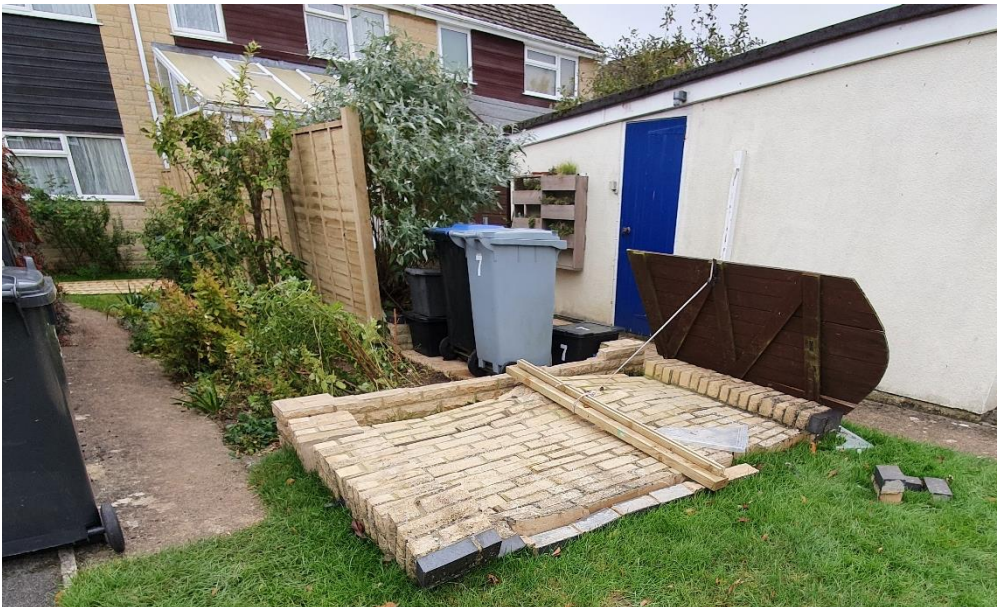
In The Tennis, there were two collapsed walls opposite each other. One had collapsed to the SW, the other to the NE.

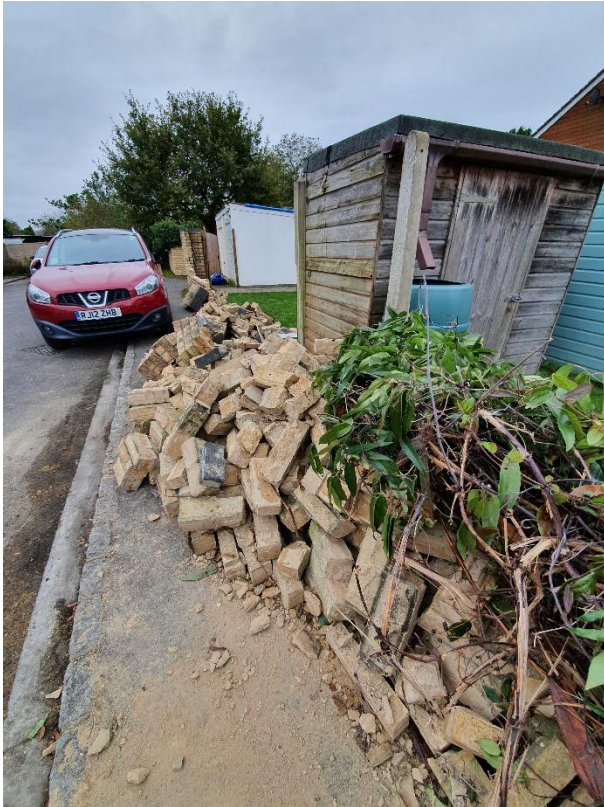
A resident in The Tennis described a complex mix of damage. As well as the wall collapsing, part of the garage roof had come off, a large, substantial walk-in animal run had collapsed and travelled SW into the neighbour's property. Other items that had been moved included a very heavy picnic bench and a planted Belfast sink.

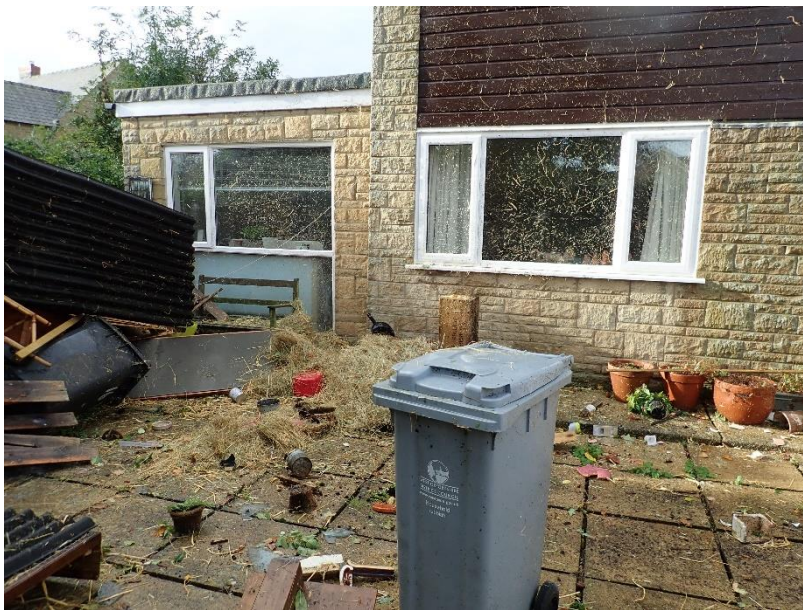
The neighbour's house was plastered to second floor level with hay and other debris. It had to be power-washed to remove the hay. In this one location, some damage was identified to have occurred in a SW direction with others occurring in a NNE direction.

An interesting small detail was that grass that had overgrown a path had peeled upwards.

Damage in central Cassington village was generally commensurate with a tornado of strength T2, although there were some elements suggesting T3 in places. Width remained around 160m

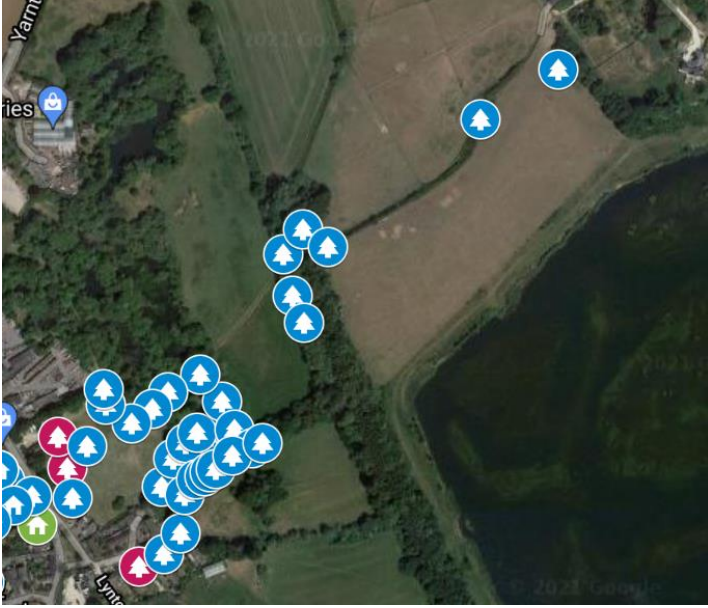
North-west of Lynton Lane.

As before, the descriptions of tree damage are only indicative. In this case not all trees could be accessed due to being on private land.

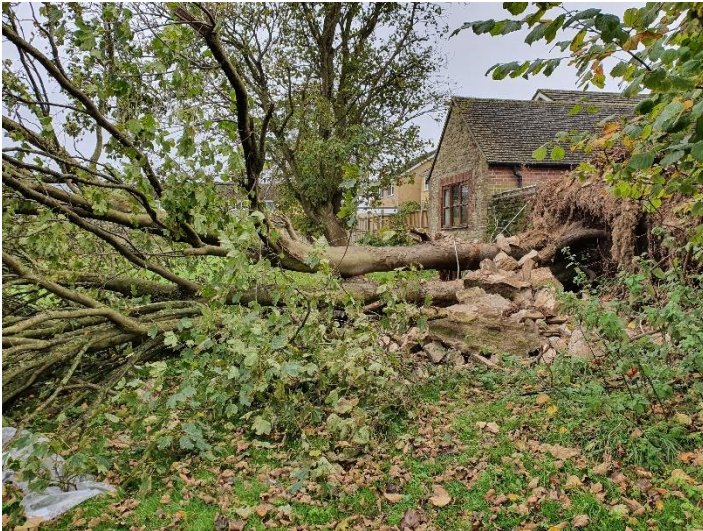
The damage in this area was similar to the damage at the A40 end of Cassington. Numerous large trees, including sycamores and oaks, were either felled, or badly damaged. In the field to the north east of the village there was damage along the periphery, in the centre and throughout the wooded area.

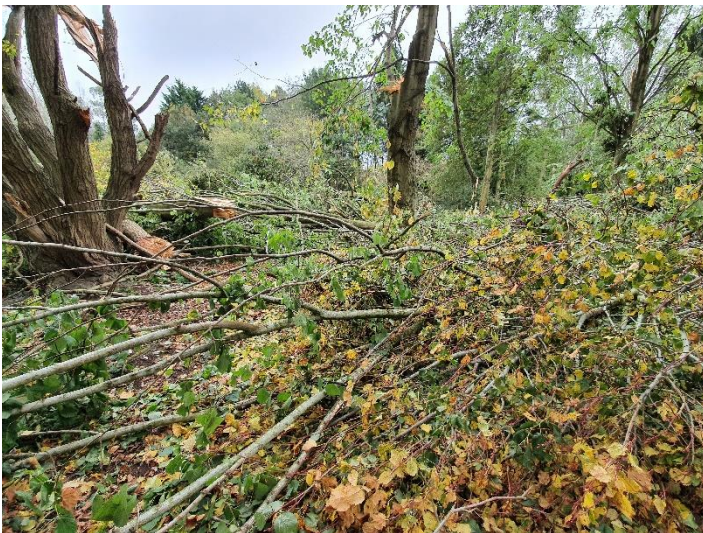
It was clear that the trees had been twisted by the winds. They lay generally in a north-easterly direction.

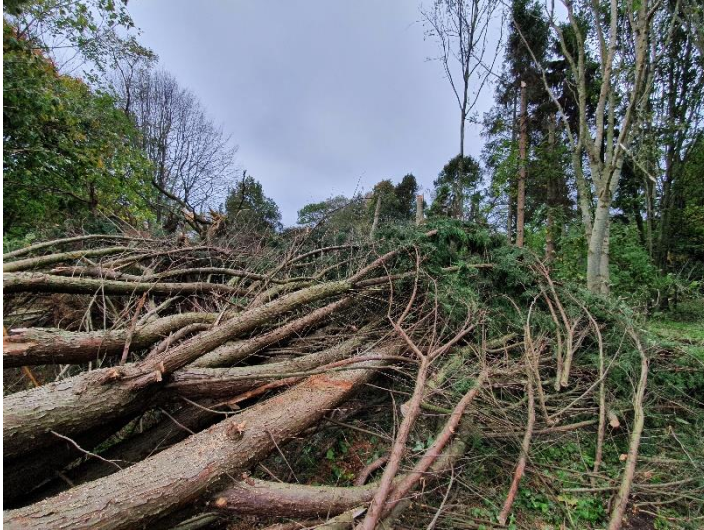
Property owners on Lynton Lane showed the damage that their wooded area had received. The trees had been planted by the gentleman in 1973/1974 and consisted of a mix of tree types. They estimated that they had lost around twenty of their trees.

The tornado in this area was around a T3 strength and approximately 150m wide.

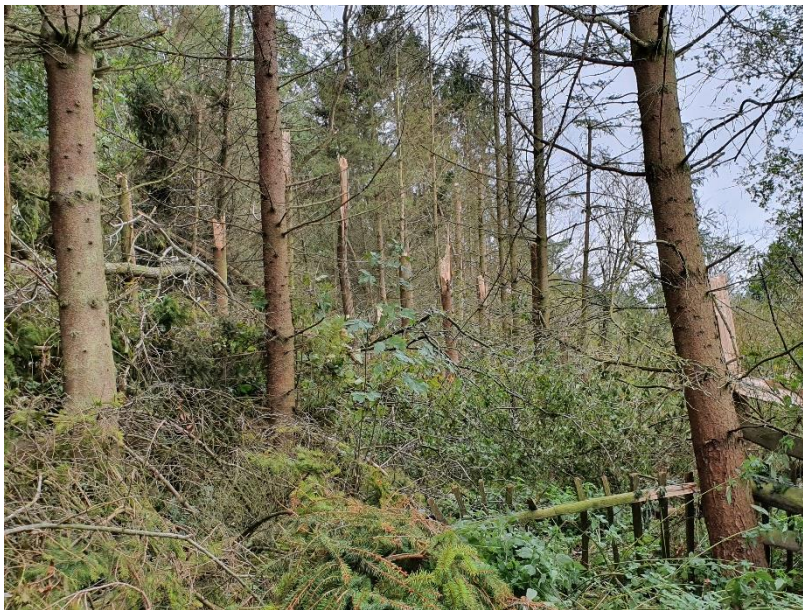
A footpath led to another tree boundary. Most of the damaged trees could not be accessed as they were on private land, but the front edge contained a number of snapped trees. On the back edge of this there were some trees that had clearly fallen to the north east.

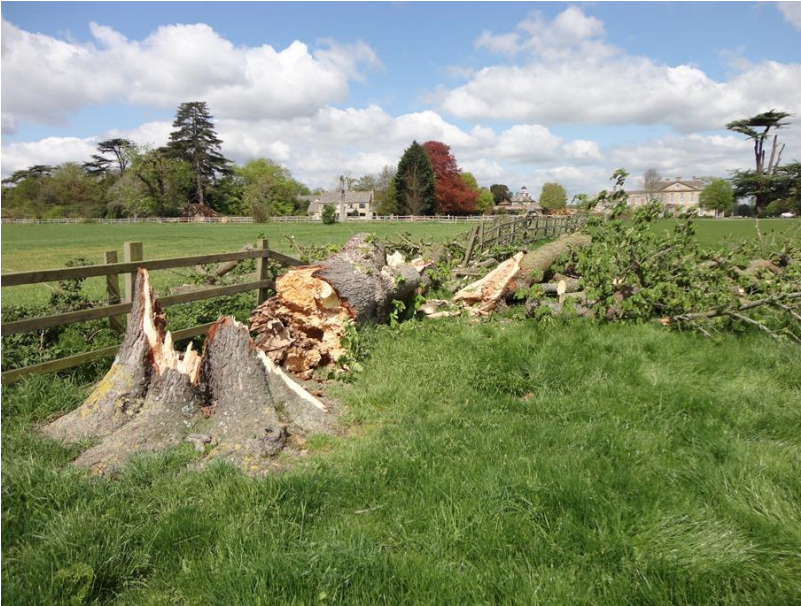
Cokethorpe School. This tree had snapped in two places.
